ADVISORY CIRCULAR 43-16A

AVIATION MAINTENANCE ALERTS

**ALERT
NUMBER
287**

**JUNE
2002**

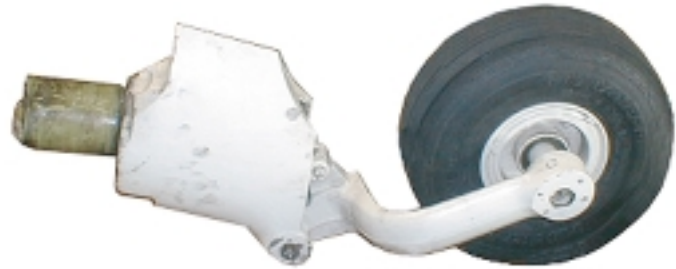
While investigating the accident, an inspector discovered the bottom half of the nose gear strut housing was fractured at the collar assembly. (Refer to the illustration.) Both “tow limit” stop bolts and a nose steering rod-end were bent and distorted. These defects indicated the strut failure resulted from excessive stress imposed when the turn limits were exceeded while moving the aircraft on the ground.

It seems obvious that prevention of this type defect resides in proper training and motivation of personnel!

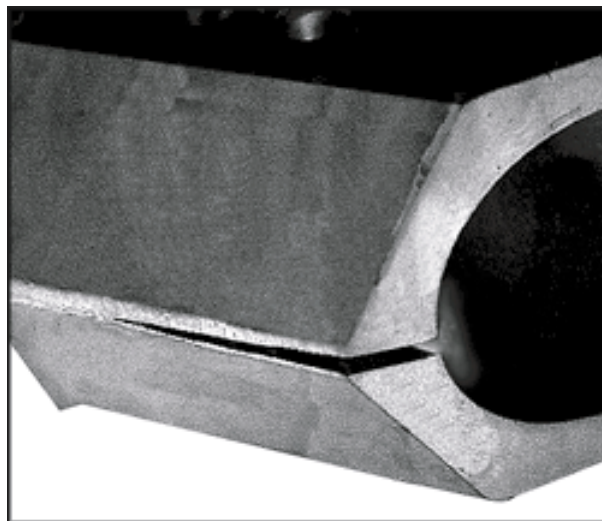
During the first scheduled inspection after the owner purchased the aircraft, the right main landing gear attachment fitting was found cracked.

The fitting (P/N 2241100-1) attaches the main landing gear spring to the axle and wheel assembly. The crack compromised the structure and security of the gear and could lead to separation of the axle and wheel assembly. (Refer to the illustration.)

Before the new owner purchased this aircraft, it had been operated in a salt-air environment over a long period of time. He gave no other reason for this defect.

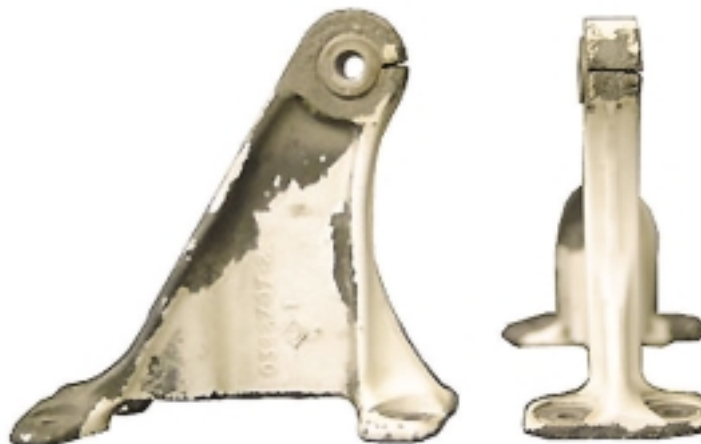
During a scheduled inspection, a technician discovered the inboard aileron hinge bracket was broken.

The inboard aileron hinge brackets (P/N 0322709 and P/N 0322709-1) are constructed of magnesium, and magnesium is highly susceptible to the effects of corrosion. This aileron hinge bracket was cracked all the way across the bearing boss. The aileron was in danger of separation from the aircraft. (Refer to the illustration.)

The FAA Service Difficulty Program data base contains nine additional reports of similar defects. Also, several aircraft accidents have been attributed to aileron hinge bracket(s) failure.

Supplemental Type Certificate (STC) SA00871WI is available and offers a new aileron hinge bracket that is made of aluminum. The new parts included in the STC kit are purported to be stronger and more corrosion resistant than the original equipment hinge brackets. Even though the magnesium aileron hinge brackets may appear to be in good condition, their airworthiness cannot be determined until they are cleaned and the paint is removed.

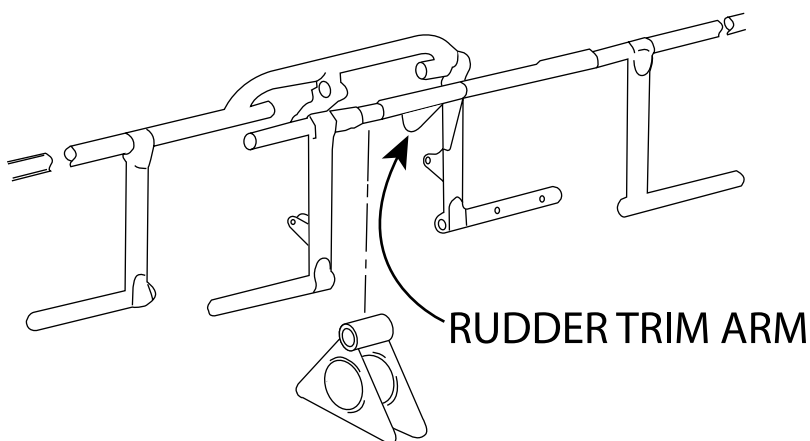
During an annual inspection, a technician discovered the rudder trim arm was broken.

The rudder trim arm (P/N 66661-000) separated from the rudder bar and displayed excessive wear and scoring at the pivot bearing points. (Refer to the illustration.) The submitter attributed the scoring and wear on the bearing points to a lack of lubrication. He suspects the main cause of the damage was movement of the rudder trim control with the aircraft stationary on a hard surface.

The submitter suggested placing the rudder trim in a “neutral” position when taxiing the aircraft to allow free movement of the nose steering mechanism.

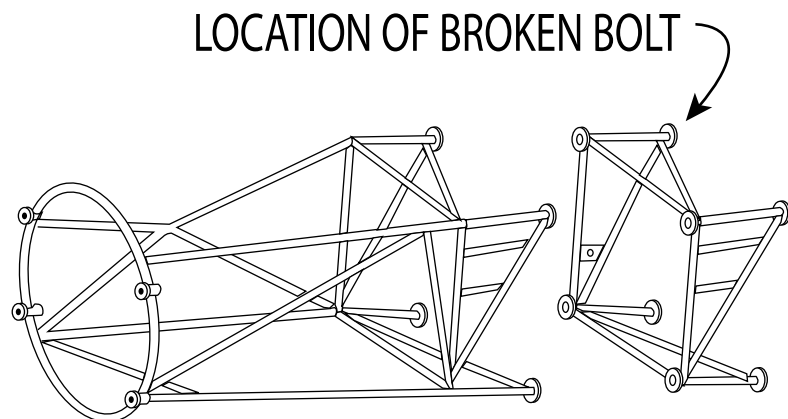
While conducting a scheduled inspection, the technician discovered an engine mount bolt was broken.

The top right engine mount bolt (P/N 553-344) was broken at the firewall. (Refer to the illustration.)

The mount bolts are due a time change at 7,500 hours. They should be replaced during engine overhauls or whenever they become loose or defective. These bolts had not attained 7,500 hours of operation, and the submitter did not give the last engine overhaul time.

Considering the critical nature of these bolts, they should be given close attention during inspections and maintenance.

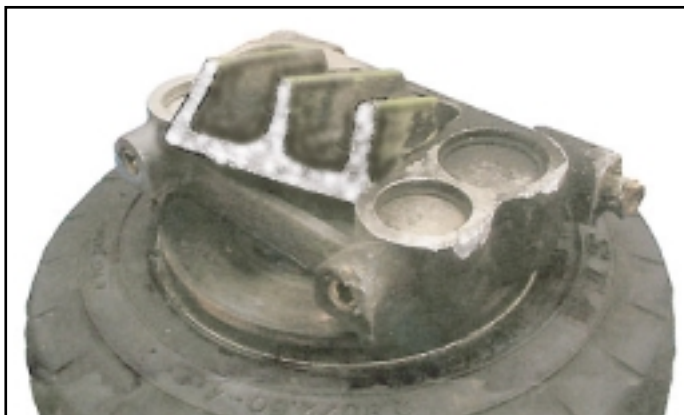
While investigating the accident, an inspector determined the left main gear separated when it contacted the runway. The gear leg failed at the aluminum casting (P/N LG93) that attaches to the wheel assembly. (Refer to the illustration.) Markings on the gear leg casting indicated it was manufactured in 1985. There was no evidence that the part was previously damaged or cracked.

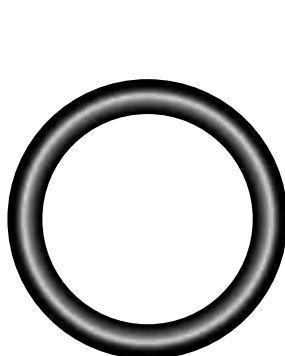
NORMAL

The owner picked up the aircraft and while taxiing for takeoff the engine failed. All attempts to restart the engine were futile and maintenance personnel brought the aircraft back to the hangar and investigated the problem. They found the engine suffered from fuel starvation and, investigating further, found fuel was obstructed at the fuel selector valve. The selector valve was removed and disassembled revealing the “O” ring seals were swollen or enlarged twice their original size. (Refer to the illustration.)
